NASA Technical Memorandum 101351
IEPC-88-035

Successful Completion of a Cyclic Ground Test of a Mercury Ion Auxiliary Propulsion System

David R. Francisco, Charles A. Low, Jr., and John L. Power
Lewis Research Center
Cleveland, Ohio

Prepared for the
20th International Electric Propulsion Conference
cosponsored by the DGLR, AIAA, and JSASS
Garmisch-Partenkirchen, West Germany, October 3-6, 1988

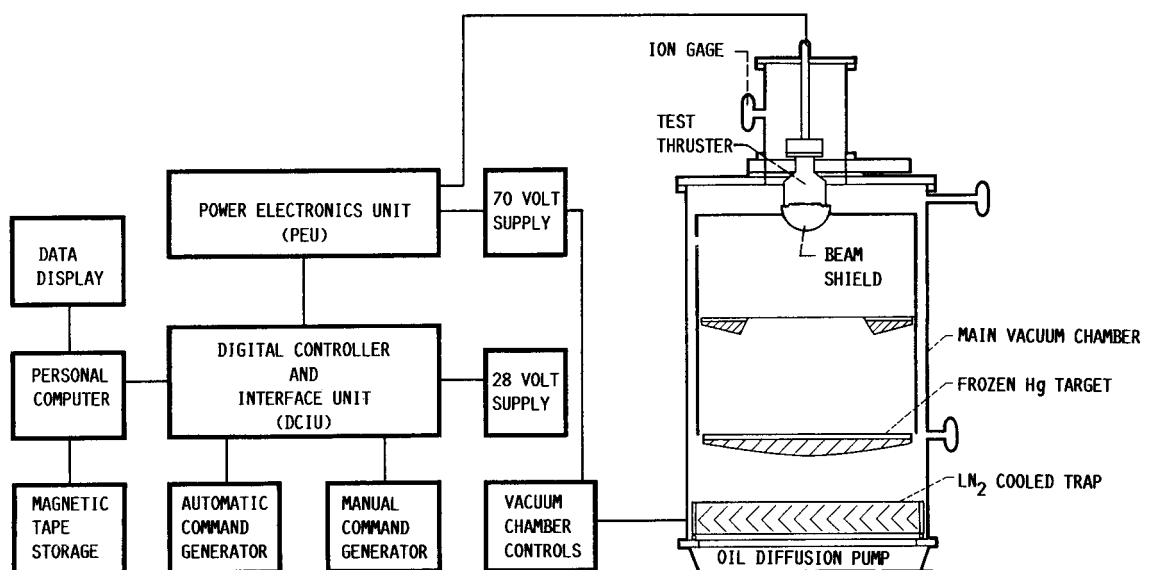
FIGURE 1. - GROUND TEST FACILITY AND ELECTRONICS BLOCK DIAGRAM.

The test chamber consisted of a 0.89 m (35 in.) diameter by 1.96 m (77 in.) high cryopumped vacuum facility with a frozen mercury target (Fig. 1). The chamber is also equipped with a 0.31 m (12 in.) diameter bell jar for isolation of the thruster. When test chamber vacuum deteriorated, the thruster was retracted into the bell jar and flooded with gaseous argon. The operating pressures of the facility during full beam operation of the thruster was maintained at 3×10^{-6} torr or better and at beam off the pressure was 5×10^{-7} torr. A detailed description of the vacuum facility is given in Ref. 3.

An automatic command generator was used to cycle the thruster ON and OFF. The automatic command generator sent a 16 bit command to the DCIU to turn the thruster ON and another 16 bit command to turn the thruster OFF. The DCIU control software performed the actual thruster startup and shutdown procedures on receipt of these commands. A cycle consisted of a 3 hr 20 min ON time which included the 25 min startup period, and a 1 hr 30 min cool-down (OFF) period. Figure 1 shows a block diagram of the electronics used to operate the thruster.

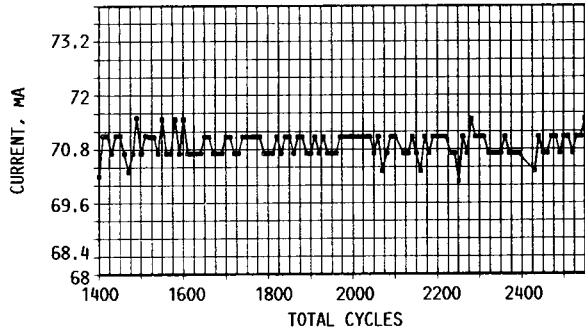
FIGURE 2. - SCREEN CURRENT.

The screen (beam) current (SI) shown in Fig. 2 did not fluctuate more than 1.20 mA (3 counts) throughout the test. The nominal value was 71.0 mA. A slightly lower value of SI was experienced during the first cycle after the thruster was restarted, but this was corrected for subsequent cycles. The constancy of the plotted data demonstrates the effectiveness of the beam current control loop in the flight software.

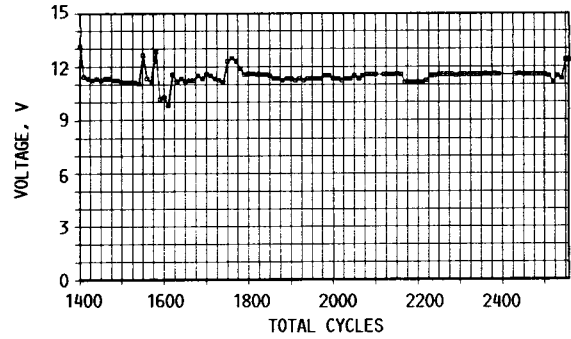
FIGURE 5. - DISCHARGE KEEPER VOLTAGE.

The discharge keeper voltage (DKV) was constant over the test except for the period of oscillations in the DKI. The nominal value of DKV was 11.2 V and as can be seen from the plot of DKV shown in Fig. 5 varied less than ± 1 V throughout the test. The change in the DKI setpoint at cycle number 1620 did cause a slight increase in the DKV (less than 0.5 V).

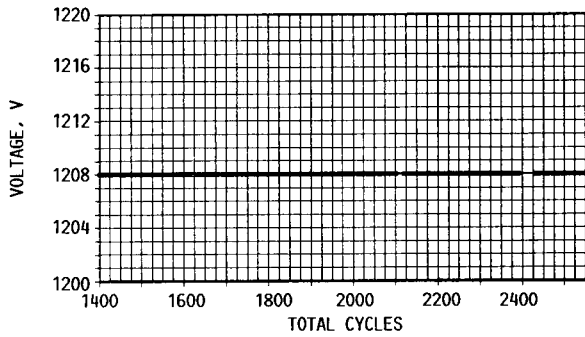
FIGURE 3. - SCREEN VOLTAGE.

The screen voltage was 1208 V and did not vary throughout the test (Fig. 3). The telemetry on this supply was near its upper limit. An actual measurement was made and it agreed with the telemetry value.

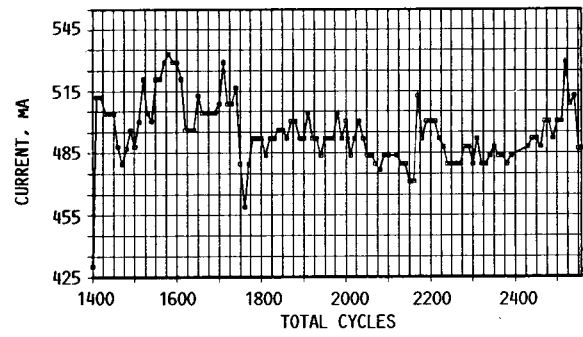
FIGURE 6. - DISCHARGE CURRENT.

The discharge current (DI) also varied. As can be seen in Fig. 6 the DI varied about ± 30 mA from a nominal 490 mA value. The largest values occurred when the oscillations in the DKI were observed and are believed to be due to the noise in the main discharge. The noisy discharge was a major contributor to the scatter in the DI data.

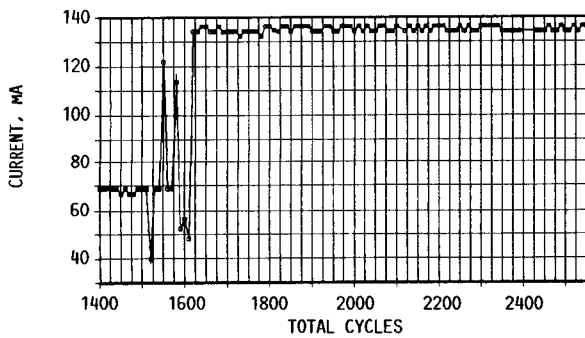
FIGURE 4. - DISCHARGE KEEPER CURRENT.

Figure 4 shows the variation in the discharge keeper current (DKI). The DKI was initially set at setpoint 0 which is 60 mA. But at cycle 1520 the DKI began to fluctuate and as the test progressed the variations increased. The DKI varied from a low value of 40 mA to a peak value of 123 mA, which was apparently due to noise on the main discharge. At cycle number 1620 the DKI was changed to setpoint 1 (120 mA) and this corrected the DKI oscillations. From cycle 1620 to the end of the test the DKI did not vary more than 2 mA. The cause of the change in operation has not been thoroughly investigated at this time. A possible reason is that the PEU-thruster entered an unstable region of control and by changing the setpoint the PEU-thruster entered a stable region of operation.

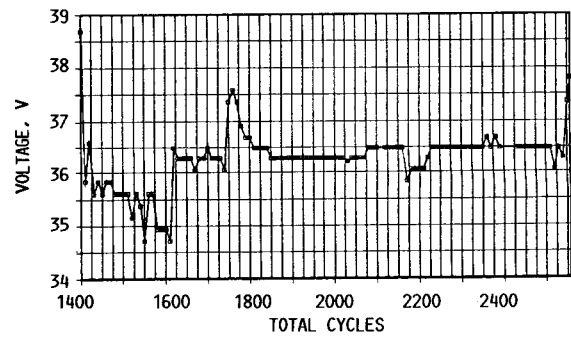
FIGURE 7. - DISCHARGE VOLTAGE.

The discharge voltage (DV) (Fig. 7) also had noticeable variations during the period of DKI's fluctuations. After the setpoint change in DKI the DV did not vary by more than ± 0.75 V. The discharge (main) vaporizer had a feedback signal for control which was the difference between the discharge voltage and discharge keeper voltage. This difference was maintained at 26.5 V. The slight increase in DV after the DKI setpoint change reflects the slight increase of DKV at the higher setpoint.

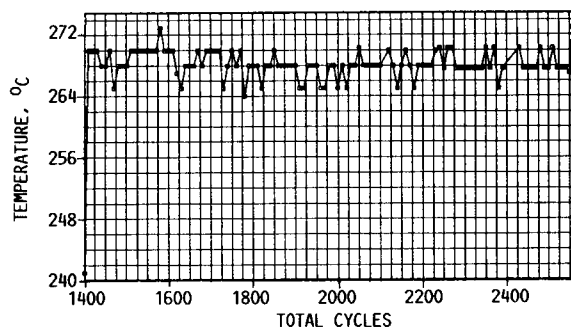
FIGURE 8. - DISCHARGE VAPORIZER TEMPERATURE.

The discharge vaporizer temperature (DVT) remained fairly constant over the entire test. From Fig. 8 it can be seen that the temperature varied approximately ± 2.5 degrees from a mean value of 268 °C during the test period after cycle 1620. The resolution of the data was not sufficient to make small flowrate changes observable. However, the slightly higher value of DVT recorded prior to cycle 1620 is significant. This higher value of DVT is due to the effect of the DKI and DKV oscillations on the main vaporizer control loop operation during this period of operation. This effect caused a higher than nominal discharge propellant flowrate.

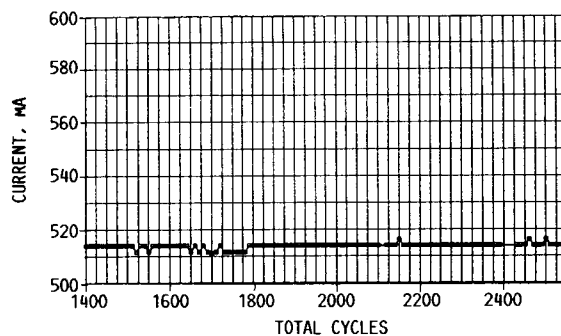
FIGURE 12. - NEUTRALIZER KEEPER CURRENT.

Figure 12 shows that the neutralizer keeper current (NKI) was maintained at the nominal 500 mA setpoint until cycle 2547. At cycle 2547 NKI was changed to the 600 mA setpoint to correct the coupling problem. At both setpoints the NKI remained constant and operated nominally.

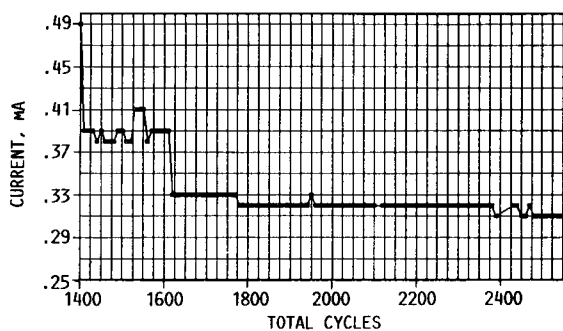
FIGURE 9. - ACCELERATOR CURRENT.

The accelerator current (ACCI) which is shown in Fig. 9 declined from 490 mA at the re-start of the test to 390 mA at cycle 1620 then to 320 mA and finally to 310 mA at the conclusion of the test. The initial reduction shows the reacquisition of the nominal thruster performance after the long period of thruster storage and facility inactivity. The decrease at cycle 1620 is due to the reduced main vaporizer flowrate that occurred when correcting the DKI oscillations (see DKI section) by increasing the DKI setpoint. The reduced flowrate improved the propellant efficiency which reduced the neutral losses and the charge exchange ion production. The further decrease in ACCI is principally due to the reduced collection area of the accelerator grid caused by erosion. It should be noted³ that a portion of the measured ACCI value is a constant facility effect arising from the contribution of back-sputtered neutrals from the frozen mercury target to the charge exchange ion production near the accelerator. Both this facility effect and the reduced propellant utilization up to cycle 1620 were major contributors to the charge exchange ion erosion of the accelerator noted at the conclusion of the test.

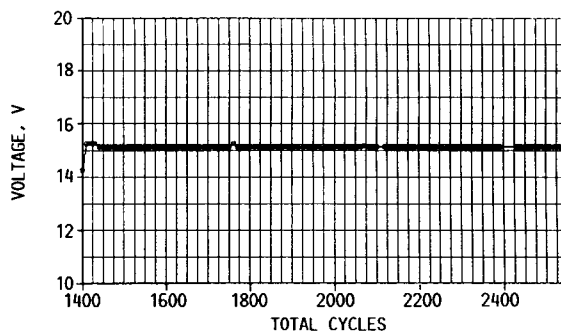
FIGURE 13. - NEUTRALIZER KEEPER VOLTAGE.

The neutralizer keeper voltage (NKV) is shown in Fig. 13. It was held constant at 15.2 V over the entire test because this value was the reference value maintained for the neutralizer vaporizer control loop. This evidently resulted in a significant decrease in the neutralizer flowrate, which is discussed in the following section. When the NKI setpoint was increased the NKV reference value was also increased to give a flowrate conducive to good coupling.

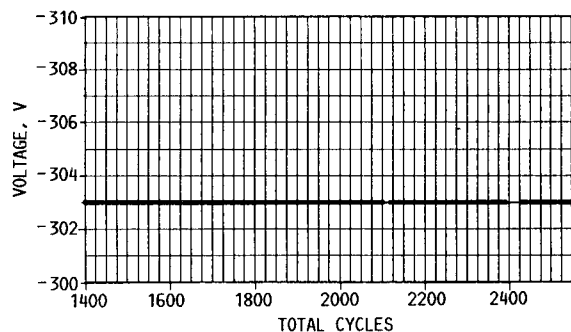
FIGURE 10. - ACCELERATOR VOLTAGE.

The accelerator voltage was -303 V and remained constant throughout the test (Fig. 10).

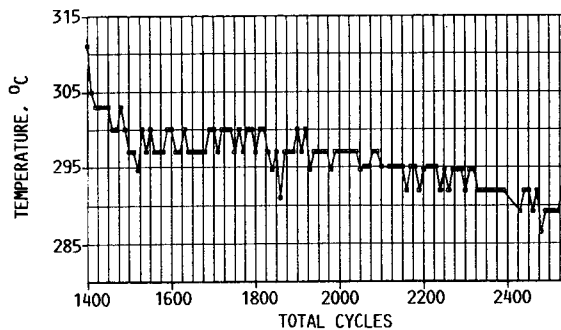
FIGURE 14. - NEUTRALIZER VAPORIZER TEMPERATURE.

The neutralizer vaporizer temperature (NVT) which is shown in Fig. 14 slowly decreased throughout the test. This resulted from a continual decrease of the NKV versus flowrate characteristic, which caused the flowrate and NVT (given the fixed reference value of NKV) to slowly decrease. The gradual decrease of the neutralizer flowrate is closely associated with the increase in the NFPV (Fig. 11). The jump in NVT at cycle 2547 was due to the deliberate change in the NKV reference value for the vaporizer control loop made when the NKI setpoint (Fig. 12) was changed. The new NKV reference value was chosen to achieve a flowrate giving good coupling.

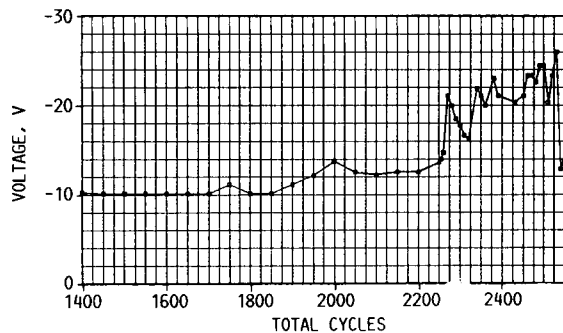
FIGURE 11. - NEUTRALIZER FLOATING POINT POTENTIAL.

Figure 11 shows the neutralizer floating point potential (NFPV) from cycle 1400 to cycle 2557.

The NFPV remained constant at -10.1 V for the first 400 cycles and then slowly began to rise. From cycle 2250 to 2533 the NFPV varied from -16 to -26 V. At cycle 2534 a loss of a liquid nitrogen supply caused a facility failure and contamination of the thruster. After the LN₂ failure the neutralizer failed to neutralize the ion beam. After re-conditioning of the neutralizer cathode and changing the neutralizer keeper current setpoint (see next section) full beam neutralization was reacquired at satisfactory floating point voltages. The process of achieving satisfactory neutralizer performance was gradual and by cycle 2557 the NFPV dropped to a value of -15.5 V. The increasing coupling voltage noted from cycle 2250 is apparently related to decreasing neutralizer flowrate (see NVT section). The coupling voltage increase was not due to an isolator leak or to the accretion of material in the keeper orifice (discussed in physical inspection section) which had been sputtered from the neutralizer tip. Both of these effects were observed in a prior durability test of an engineering model IAPS thruster (Ref. 6). Visual inspection of the thruster during operation and at the conclusion of the test showed no mass build up or aperture restriction of the neutralizer keeper orifice (see section on physical inspection).

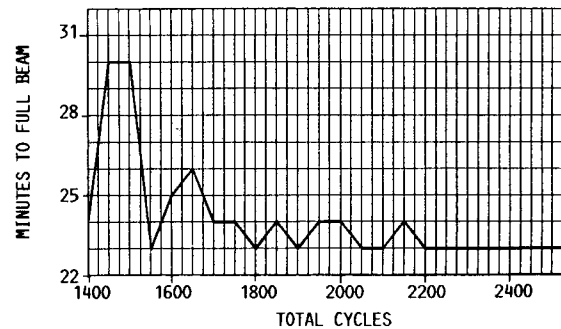
FIGURE 15. - TIME TO FULL BEAM.

Another important factor for routine thruster operation is the time required for the thruster to achieve full beam from a cold start. Figure 15 presents the startup time for this portion of the cyclic test. For the first 150 cycles (1400 to 1550) the thruster was manually cycled twice a day. This led to the thruster reaching a colder OFF cycle temperature thus causing a longer startup period. After the automatic command generator was installed and automatic cycling initiated, the startup period was 23.5 min and remained constant throughout the remainder of test. The startup time was constrained by the PEU heater supply limits.

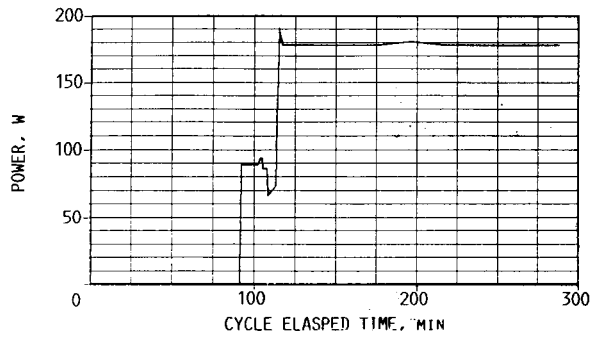
FIGURE 16. - TOTAL POWER CONSUMED.

Figure 16 shows the input power required by the PEU to run the thruster during cycle 2125. The PEU power plotted is the product of the 70 V bus current and voltage. An initial draw of 90 W is needed to heat the two vaporizer heaters and the two cathode tip heaters at nearly their maximum power settings. The discharge cathode is ignited at 103 min, the main discharge is ignited at 104 min and the neutralizer is ignited 1 min later. The main discharge is operated at high current for 5 min to further heat the thruster and aid in evaporating mercury condensed on thruster surfaces. After the neutralizer ignites the power draw drops from 95 to 65 W while the neutralizer vaporizer cools from 360 to 290 °C. After neutralizer operation has been established at the normal running conditions and the

high current operation of the main discharge has been concluded, "pre-beam" operation begins. The "pre-beam" operation elevates the discharge keeper current to 380 mA and adjusts the discharge propellant flowrate for high voltage application. After 3 min of "pre-beam" operation the high voltage is turned on and this results in a peak power draw of 189 W. The beam current control software brings the beam current up to full beam by 115 min into the cycle, or 24 min after the ON command was issued. Once the thruster is at full beam the power decreases to 178 W and remains there for the duration of the cycle.

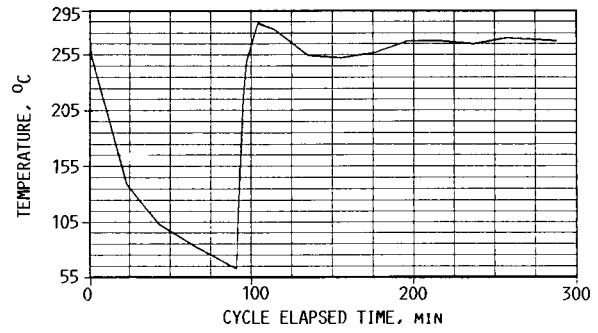
FIGURE 19. - DISCHARGE VAPORIZER TEMPERATURE.

The discharge vaporizer temperature (DVT) history during cycle 2125 is plotted in Fig. 19. As seen from the plot, the discharge vaporizer cools to 65 °C during the 90 min OFF (cooldown) period. Once the ON command is given high power is applied to the vaporizer heater and the DVT reaches the cathode starting level of 285 °C in approximately 10 min. The cathode is held at the starting level for 3 min before ignition is attempted. The cathode ignition was immediately successful (which is typical of a normal startup for this test). Following ignition and up to high voltage application (at 115 min), the DVT is controlled at near its normal running level which is a few degrees below the starting level.

After the high voltage has been applied at 115 min into the cycle and full beam is achieved the discharge vaporizer power is controlled by the software control loop. The control loop maintains a fixed reference value for the difference between the discharge voltage and the discharge keeper voltage. The drop in DVT to 251 °C during the initial full beam operation is due to the evaporation of mercury condensed in the main isolator during startup from a cold condition. Supplementary tests demonstrated that the evaporation of the condensed mercury caused the vaporizer to be automatically controlled at a correspondingly reduced flowrate. After all the condensed mercury evaporates (as seen to have occurred at approximately 200 min into the plotted cycle) the DVT rises to a running level of 267 °C. The DVT remains at this level for the remainder of the cycle.

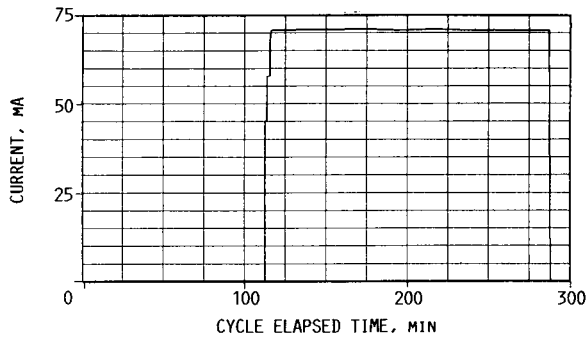
FIGURE 17. - SCREEN CURRENT.

After the high voltage is applied, the screen current (SI) is rapidly ramped up to its full beam level of 71 mA 115 min into the cycle (24.0 min after the ON command). It is maintained constant at this value to within 1 percent by the beam current control loop in the software until the thruster is commanded OFF. The SI during cycle 2125 is displayed in Fig. 17.

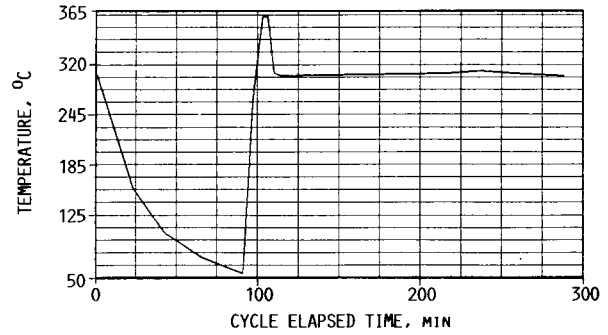
FIGURE 20. - NEUTRALIZER VAPORIZER TEMPERATURE.

The neutralizer vaporizer temperature (NVT) plotted for cycle 2125 in Fig. 20 cools down to 57 °C during the OFF period. When the ON command is given high power is applied to the neutralizer vaporizer heater and NVT rises to 364 °C within 14 min. It is then held at this level for three more minutes before ignition is attempted. The ignition was instantly successful. After neutralizer ignition,

the vaporizer is allowed to cool down to below its normal running level and the neutralizer keeper voltage is tested to assure that there is not an excessive amount of mercury vapor in the thruster. After the test is successfully completed (110 min into cycle 2125), the operation of the vaporizer is placed into closed loop control for the remainder of the cycle. This control resulted in NVT holding within a one count range of 292 to 295 °C throughout the remainder of the cycle.

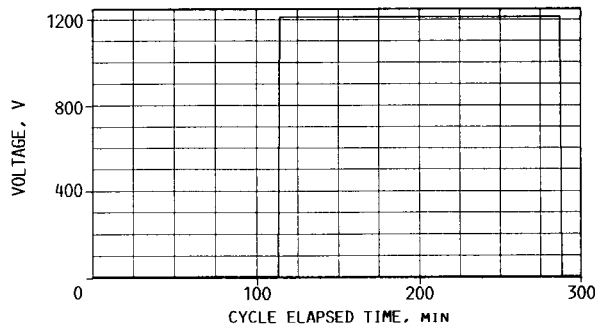
FIGURE 18. - SCREEN VOLTAGE.

The screen voltage (SV) shown in Fig. 18 rises to its fixed value of 1208 V 115 min into the cycle and remains at this level throughout the cycle.

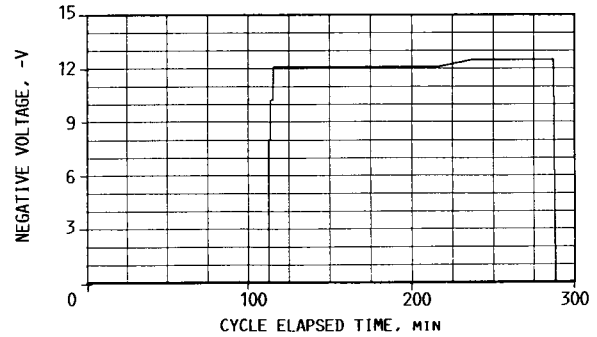
FIGURE 21. - NEUTRALIZER FLOATING POINT POTENTIAL.

The neutralizer floating point potential (NFPV) for cycle 2125 is plotted in Fig. 21. The NFPV remains at 0 V until the high voltage is applied, which occurred at 115 min into the cycle. Once the high voltage is applied the NFPV rises in steps (following the increase in beam current) until at full beam the value of NFPV is -12.1 V. Somewhat later the NFPV reached -12.5 V where it remained until the end of the cycle.

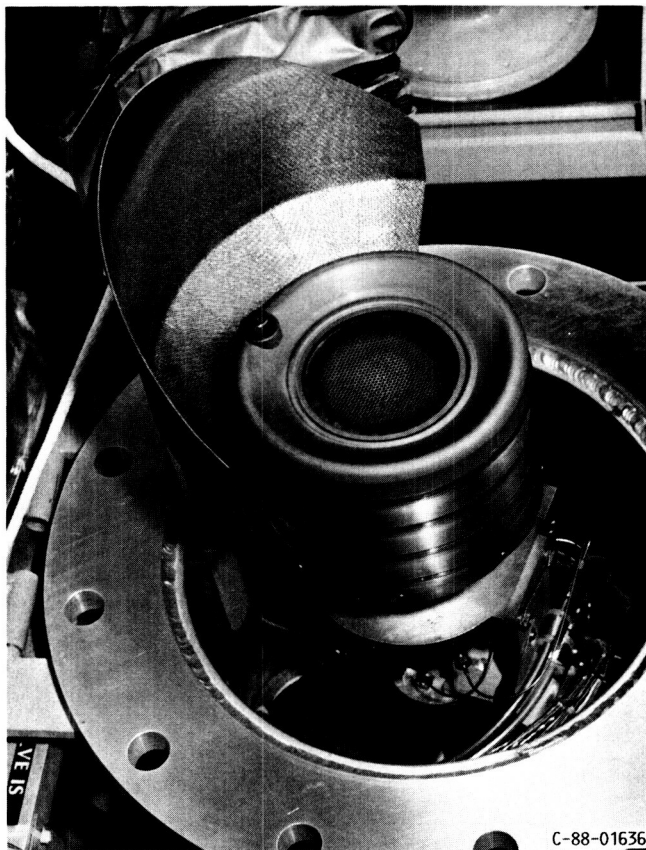
FIGURE 22. - THRUSTER-BEAM SHIELD UNIT (POST TEST).

Figure 22 shows the thruster exterior and the beam shield interior at the end of the test. The beam shield interior showed three regions (bands) of erosion/deposition. The boundaries of these bands were parallel arcs at successive downstream locations. The region at the beam shield tip was approximately 4 cm wide and showed significant net erosion. The shield thickness measured at the tip was 0.92 mm compared with its original thickness of 1.15 mm. This indicates that the shield could withstand another 25 000 hr of thruster operation at the same conditions before being completely eroded through by the high energy divergent fringing ions of the ion beam. The original 2000 Å molybdenum coating on the beam shield interior was also completely removed in the tip region. Point to point resistance measurements made in the tip region showed the high resistance of the bulk fiber-glass-epoxy composite of which the beam shield is constructed. The intermediate region visible on the beam shield interior extended back almost to the crease connecting the downstream cylindrical and the upstream conical sections of the shield (Fig. 22). This region closely resembled its original appearance and was uneroded in thickness. Since the surface resistance measurements of this region were 500 Ω, this region apparently retained a coating of molybdenum.

The upstream region visible on the beam shield interior included all of the conical mounting section. It showed net deposition of material which was significantly nonmetallic. This was evident both from its appearance and from surface resistance measurements of greater than 50 000 Ω. It is believed that this region accumulated material from the facility (such as silicone pump oil).

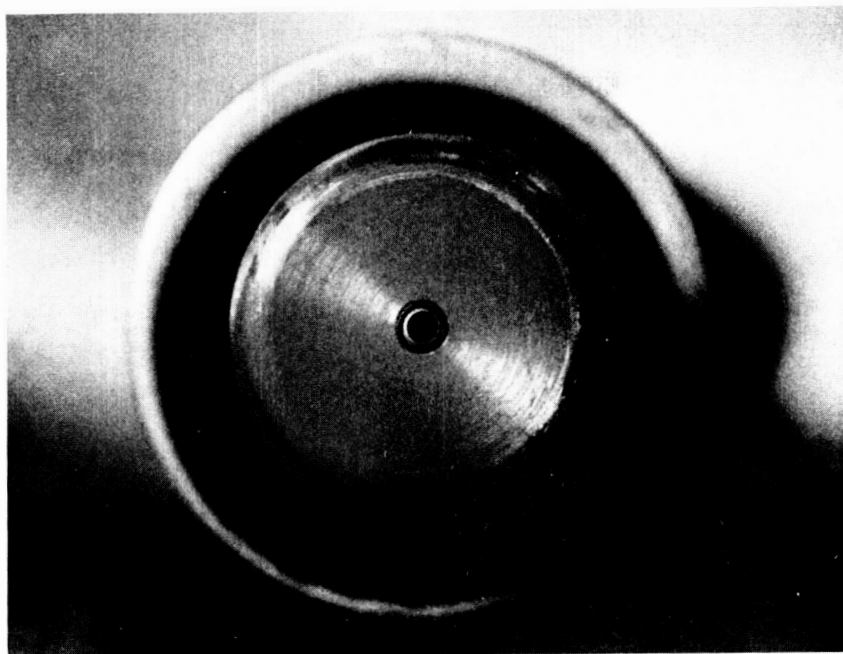
FIGURE 23. - NEUTRALIZER KEEPER CAP.

The neutralizer assembly appeared clean and free of visible deposits in the post test inspection. Figure 23 shows the enclosed neutralizer keeper cap. There was no deposition within the keeper orifice nor on the upstream or downstream surfaces adjacent to it. The absence of deposits on the upstream surface was verified by telescopic observation at an

oblique angle of the keeper orifice with the keeper discharge operating, just prior to the conclusion of the test. The keeper orifice also showed no erosion or enlargement and its diameter was unchanged from the initial value of 1.78 mm. To the extent it could be viewed through the keeper orifice, the neutralizer tip also showed no visible erosion. These observations are in substantial contrast to the post test condition of the neutralizer from the IAPS thruster life test reported in Ref. 6. That test resulted in extensive sputter erosion of the neutralizer tip, with deposition of the sputtered material in the keeper orifice and on the upstream surface around it.

Point to point resistance checks were made on the exterior surface of the tantalum neutralizer keeper cap. Resistance values were low (1 to 2 Ω) on the side surface. Near the orifice on the downstream surface the value was approximately 70 Ω and farther away from the orifice the resistance measured 150 to 200 Ω . It can be concluded from these measurements that dielectric material originating from the facility (such as silicone pump oil) had deposited on the keeper cap. The downstream surface of the keeper cap, with its full exposure to the likely sources of contaminants, would accumulate the heaviest coating of these materials. The problem of the neutralizer to neutralize the thruster beam near the end of the test may be attributed to these facility contaminants. Prior to the neutralizer coupling problem a LN₂ failure caused a shutdown with the thruster hot and allowed the facility surfaces to warm up above normal operating conditions. This failure may have caused contaminants (dielectric material e.g., silicone pump oil) to coat the keeper cap. The slow recovery of neutralization capability with operating time following the incident correlates with the slow sputter removal of the contaminant coating.

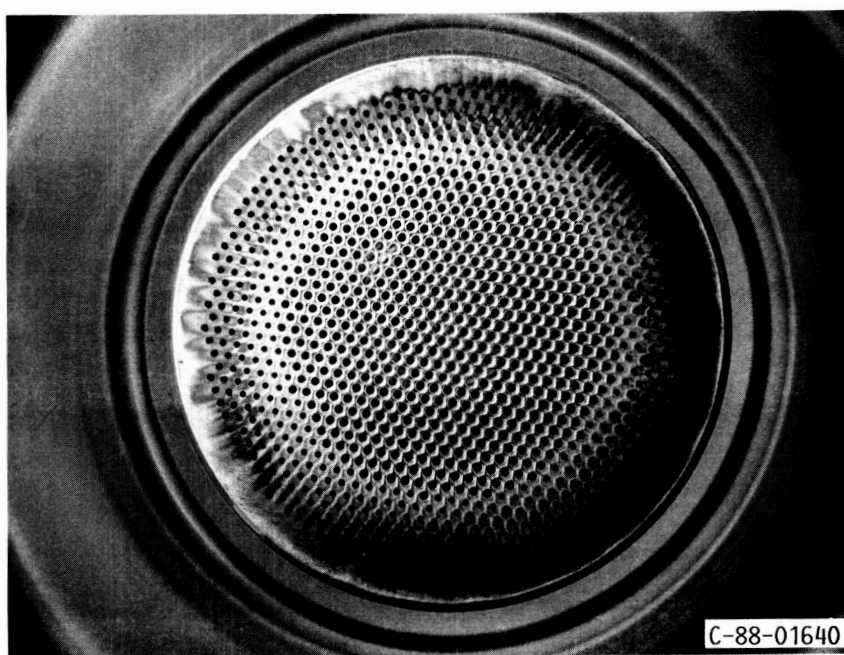
FIGURE 24. - POST TEST ACCELERATOR GRID.

The accelerator grid downstream surface, seen in Fig. 24, showed substantial charge exchange erosion. This was concentrated in the central region of the grid and showed the normal pattern of a triangular pit in the webbing between each grouping of 3 grid holes. None of the pits was observed to have penetrated through the 0.51 mm thickness of the grid. The deepest pits were judged to be more than half way through the grid. The causes of the prominent charge exchange erosion are the same as those for the high accelerator drain current observed during the test and have been previously discussed.

Moderate ion beamlet impingement erosion of the accelerator grid holes was observed. The central region holes, originally 1.14 mm in diameter, were found to be between 1.17 and 1.27 mm with one hole near the center measured as 1.31 mm in diameter. The outer region holes, originally 0.89 mm in diameter, were all found to be greater than 0.91 mm. Most were 0.94 mm in diameter with the innermost ring of these holes measuring 0.97 mm in diameter. The peripheral holes of the outside region experienced some nonsymmetric ion beamlet milling. This is generally observed in the operation of 8-cm mercury ion thrusters and is attributable to the nonsymmetric repulsion of the ion beamlets of the outer holes by the beamlets of the surrounding inner holes. Overall, the increase in the total accelerator open area due to the impingement erosion over the entire life test operation of the thruster is estimated to be 17 percent.

Only rudimentary observations could be made of the thruster discharge chamber through the accelerator grid (Fig. 24). From these observations it was established that there were no loose flakes of material in the chamber and no prominent erosion or deposition on any visible surface. The visible components were the baffle, the cathode pole piece,

and to a limited extent the upstream endplate of the chamber. The discharge cathode and the anode could not be observed without disassembling the grids.
